Level I Environmental Health Assessment

1.0 - Environmental Health Issues and Action Summary

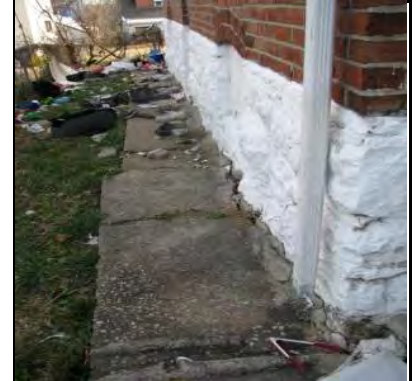
Issue: Splash blocks/extension tubing were missing on downspouts. Downspouts was also observed to be damaged.

- 1) Repair the broken downspout and install extension tubing on all downspouts to assure that water is draining away from home.
- 2) Clean out gutters and downspouts periodically to remove debris to allow proper water drainage.

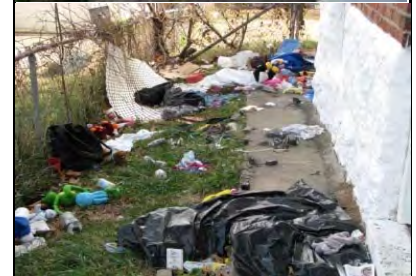
Issue: A lot of trash and broken glass pieces were observed on side and back of the home. Family reported mice and cockroach issues inside the home.

- 1) It is recommended to remove and dispose of all the trash and unwanted items from around the home in order to keep pests and odors away from home.
- 2) Safely remove and dispose of all of the glass pieces around the home in order to prevent injuries from occurring.

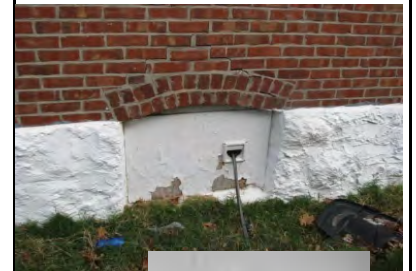
Issue: Visible gap was observed around back door of home. Holes were observed on basement windows of the home. Dryer vent opening was not sealed.

Action(s): Install weather stripping around the back door, seal and close all gaps with a proper sealant in order to prevent unwanted air, moisture and pests from entering home.

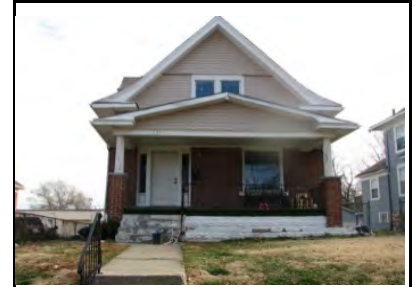
Issue: Flaking paint was observed on exterior stairs and on front porch support columns. Knowing that the house was built around the early 1900s it is possible that lead based paint may also be on some interior walls .

- 1) Since the home was built prior to 1978, there are concerns of lead-based paint in home. Lead paint "dust" is typically the exposure source for many young children due to them crawling on the floors and then placing fingers and hands in mouth. Keeping floors, windows, and around windows free of dust is recommended by "damp" dusting
- 2) If concerned about lead-based paint, it is recommended to have all surfaces in the home tested for lead by a licensed risk assessor. If lead is detected and determined that it needs to be removed, lead-safe work practices should be used at all times. Contact the Kansas City Missouri Health Department's Project Lead Safe KC program at 816-513-6008.

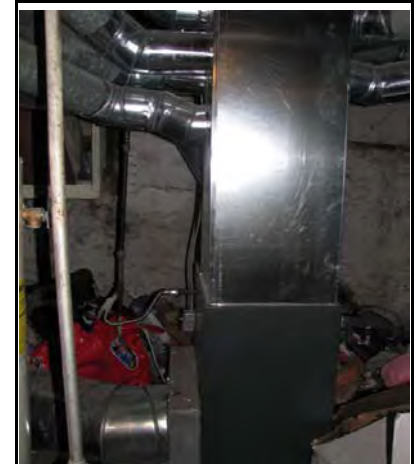
Issue: Dust was observed on furnace system. Very high levels of fine airborne particles and mold spores were measured throughout the home. Low air changes per hour was also measured from vents throughout the home. There was no filter in the furnace and fiber glass filters were observed to be stored around the furnace. Items were also observed to be stored around the furnace.

- Action(s):**
- 1) A licensed Heating, Ventilation, and Air Conditioning (HVAC) expert should assess the furnace to determine why it is not functioning. The HVAC expert should determine if the furnace need to be balanced so that filtered air is evenly distributed throughout the home. This should help improve the air quality throughout the home and decrease the amount of potential contaminants in the spaces.

- 2) Use a pleated filter in the furnace that has a Minimum Efficiency Rating Value (MERV) rating of at least 8 or a performance rating value filter of 1000 in order to capture smaller particles that are typically breathed in easily, which may cause increased upper respiratory infections.

- 3) Change the pleated furnace filter every 3 months or per manufacturer's recommendations.
 - 4) Remove clutter from around the furnace in order to prevent the risk of fire hazard and also to allow easy access to change the furnace filter.

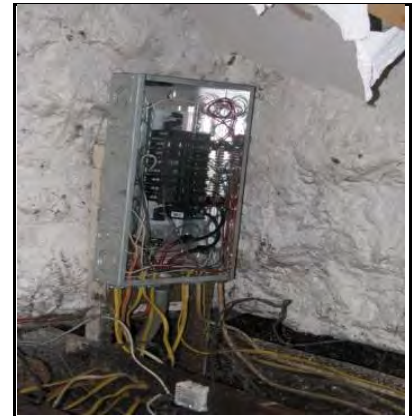
Issue: Main junction box was missing a cover in the basement. A notice of hazardous condition form was issued to the family at the time of the assessment.

Action(s): It is recommended to have a certified electrician install a cover on the main junction box to prevent the risk of electrical shock hazards.

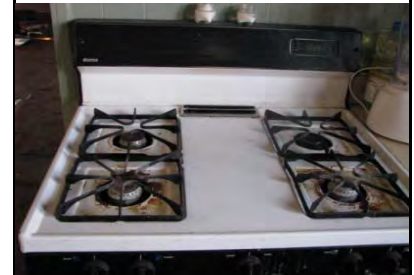
Issue: Gas stove was not exhausted to the outside. Gas leak was detected from the kitchen stove; the family was given a hazardous condition form for this issue.

Action(s): 1) It is recommended to have someone repair or replace the gas stove. A licensed plumber should address the gas leak as well. This is a health and safety concern that needs to be addressed immediately .

2) Install an exhaust fan either on the outside wall or above the stove to prevent unwanted carbon monoxide (CO) gas from building-up in the home and to exhaust cooking odors, particles, and moisture out of the home.

3) If installing a kitchen exhaust is not possible then open windows and operate fans during cooking activities.

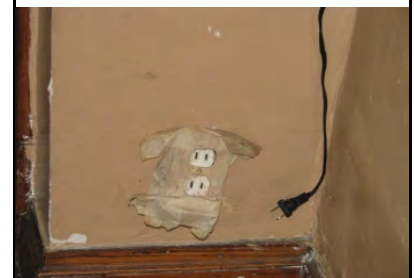
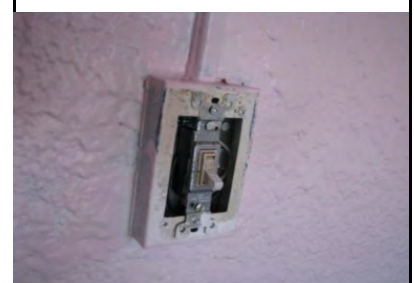
Issue: Electrical outlets and light switches were loose and/or some were missing a faceplate throughout the home. Plug covers were also observed to be missing.

Action(s): 1) Have a certified electrician install a cover on the electrical outlet to prevent the risk of electric shock hazards.

2) A plug cover should be placed into all unused electrical outlets in order to prevent small children from sticking objects into the outlet, which can be an electrical shock hazards.

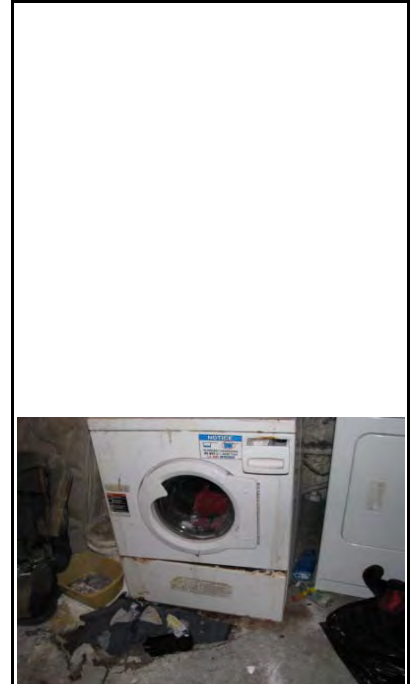
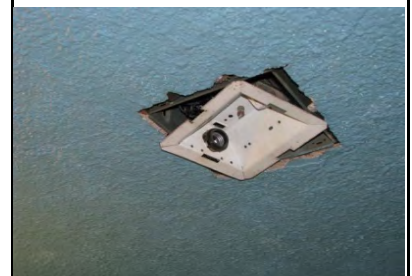
Issue: Dryer was not exhausted to the outside of the home. Bottom cover was observed to be loose on the washer.

Issue: Exhaust fan/light fixture was loose and missing a cover in the bathroom located on the first floor.

Action(s): 1) It is recommended to have a licensed HVAC expert install a safe and efficient dryer vent so that the dryer exhausts outside the home safely in order to prevent fire hazard, condensation and possible mold growth.

2) It is also recommended to clean the lint from the walls, dryer and dryer vent ducting regularly to prevent a potential fire hazard.

3) Properly replace/install and secure the bottom panel to the washer in order to prevent safety hazards from occurring.

Action(s): 1) Re-attach and install a cover on the exhaust fan in the bathroom

2) Operate fan during, and for 15 - 20 minutes after taking shower/bath to help decrease the humidity level during and to prevent mold and bacteria growth.

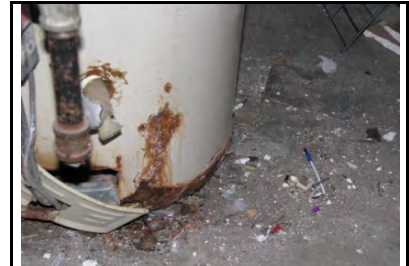
Issue: Corrosion and rust was observed on the base of hot water heater located in the basement of the home.

Action(s): A licensed Heating, Ventilation, and Air Conditioning (HVAC) professional should assess the hot water heater to replace or make necessary repairs in order to prevent future moisture issues and other safety hazards from occurring.

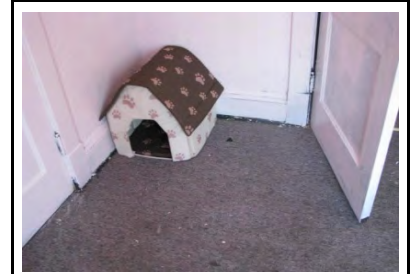
Issue: Curtains, wall to wall stained carpeting in master bedroom was present and excess dust on carpeting, window sills and floor was observed throughout the house.

2) Ideally, removing the stained carpeting in the bedrooms and switching to a hard surface flooring is recommended. This type of floor harbors less allergens and is easier to maintain.

4) "Damp dust" surfaces in the home with a damp cloth. This will help decrease the amount of dust and particles you stir up into the air and possibly exposing the child or sensitive individuals to. Refer to the safer cleaning book for recipes on non-toxic cleaning products.

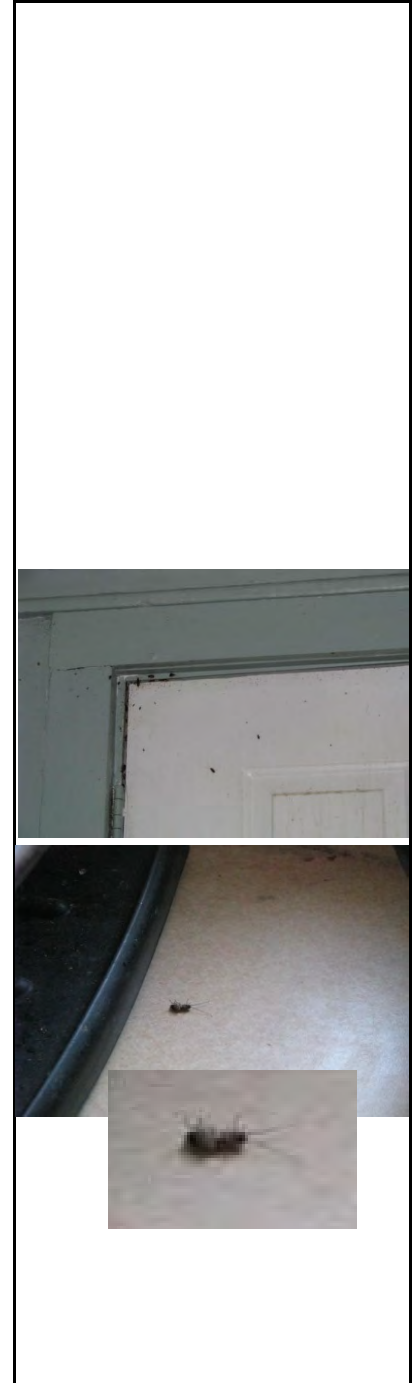
Issue: No carbon monoxide (CO) detector was observed in the home - (Healthy Home Program provided one CO detector during initial assessment).

Issue: Cockroaches were observed throughout the home .

- Action(s):**
- 1) It is recommended to place a CO detector between the sleeping areas of the home and all gas combustion sources.
 - 2) Test CO detectors once a month and change batteries twice a year during daylight savings time.
 - 3) If CO detector alarms, the family should exit the home safely and call the fire department/gas company to have the issue addressed.

- Action(s):**
- 1) It is recommended to use Integrated Pest Management (IPM) in order to reduce the population of cockroaches that are present by removing trash, picking up any food and water when not using them to also prevent pest access and contamination of those items.
 - 2) It is recommended to place all bulky food items including pet food items in storage containers with reseal-able lids to prevent pest from gaining access to those items.
 - 3) Seal any cracks and gaps that would allow insects and rodents to enter the home.
 - 4) Launder any clothes and other items in hot (130°F) water, that are easily cleaned, to destroy any cockroach and other allergens that may be present.

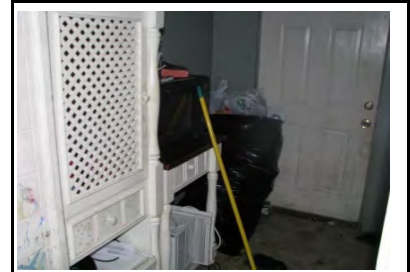
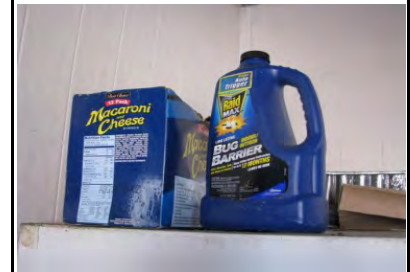
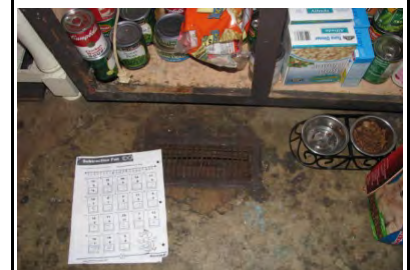
Issue: Large trash bag was observed to be full and stored in the kitchen area. Cockroaches were also observed in this area.

Issue: Pesticide container was observed to be stored next to food item on top of refrigerator.

Action(s): Replace the big trash bag with one tall kitchen trash can with a lid (provided by the Healthy Home Program) to be stored in the kitchen area only. Take out trash daily instead of allowing trash to gather inside the home for long periods of time in order to decrease odors, clutter, and keep pests from entering the home.

2) Both Medications and chemicals can be hazardous to young children if stored within reach or in easily accessible locations. Keep all medications and chemicals in a designated locked cabinet or out of reach of young children to prevent any hazardous exposures or accidental poisonings from occurring.

Action(s): 1) It is recommended to install missing cabinet doors to keep pests from food items that are stored in cabinets.

2) Install safety latches or locks on cabinets where chemicals or medicines are stored to prevent the risk of chemical poisonings.

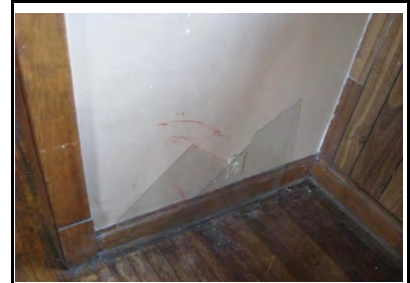
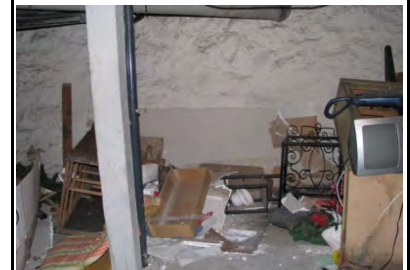
Issue: Broken glass was observed to be stored in the living room.

Issue: A lot of clutter, building materials, debris and dust were observed in the basement.

Action(s): Safely remove the broken glass in order to prevent safety hazards and injuries from occurring.

5) Remove and dispose of all unwanted building materials from home in order to prevent mold growth and dust accumulation.

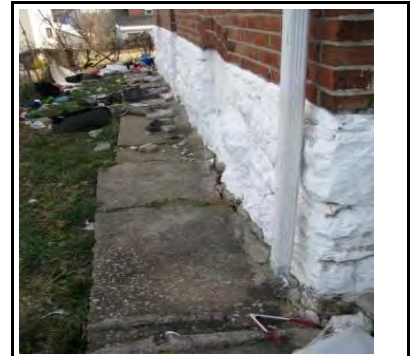
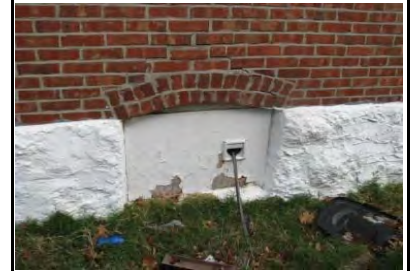
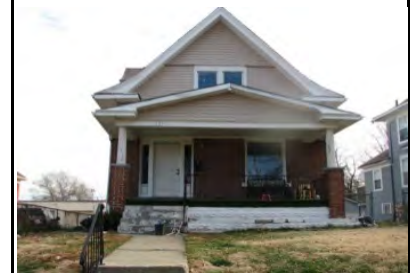
Issue: Splash blocks/extension tubing were missing on downspouts. Downspouts was also observed to be damaged.

Issue: Visible gap was observed around back door of home. Holes were observed on basement windows of the home. Dryer vent opening was not sealed.

Issue: Flaking paint was observed on exterior stairs and on front porch support columns. Knowing that the house was built around the early 1900s it is possible that lead based paint may also be on some interior walls .

- 1) Repair the broken downspout and install extension tubing on all downspouts to assure that water is draining away from home.
- 2) Clean out gutters and downspouts periodically to remove debris to allow proper water drainage.

Action(s): Install weather stripping around the back door, seal and close all gaps with a proper sealant in order to prevent unwanted air, moisture and pests from entering home.

- 1) Since the home was built prior to 1978, there are concerns of lead-based paint in home. Lead paint "dust" is typically the exposure source for many young children due to them crawling on the floors and then placing fingers and hands in mouth. Keeping floors, windows, and around windows free of dust is recommended by "damp" dusting
- 2) If concerned about lead-based paint, it is recommended to have all surfaces in the home tested for lead by a licensed risk assessor. If lead is detected and determined that it needs to be removed, lead-safe work practices should be used at all times. Contact the Kansas City Missouri Health Department's Project Lead Safe KC program at 816-513-6008.

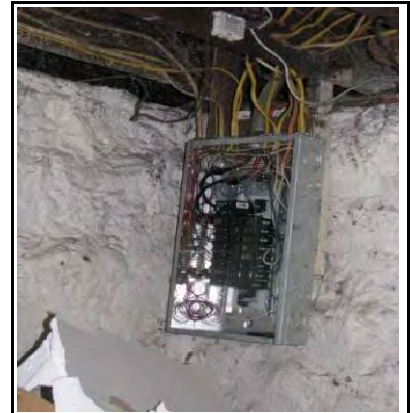
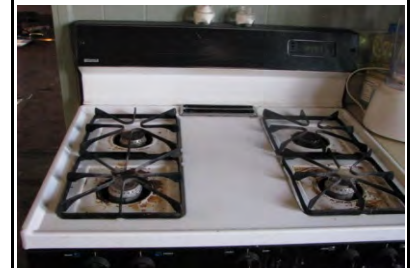
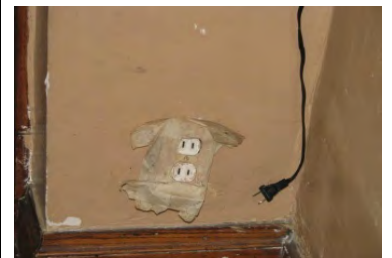
Issue: Main junction box was missing a cover in the basement. A notice of hazardous condition form was issued to the family at the time of the assessment.

Issue: Gas stove was not exhausted to the outside. Gas leak was detected from the kitchen stove; the family was given a hazardous condition form for this issue.

Issue: Electrical outlets and light switches were loose and/or some were missing a faceplate throughout the home. Plug covers were also observed to be missing.

Action(s): It is recommended to have a certified electrician install a cover on the main junction box to prevent the risk of electrical shock hazards.

Action(s): 1) It is recommended to have someone repair or replace the gas stove. A licensed plumber should address the gas leak as well. This is a health and safety concern that needs to be addressed immediately .

2) Install an exhaust fan either on the outside wall or above the stove to prevent unwanted carbon monoxide (CO) gas from building-up in the home and to exhaust cooking odors, particles, and moisture out of the home.

Action(s): 1) Have a certified electrician install a cover on the electrical outlet to prevent the risk of electric shock hazards.

2) A plug cover should be placed into all unused electrical outlets in order to prevent small children from sticking objects into the outlet, which can be an electrical shock hazards.

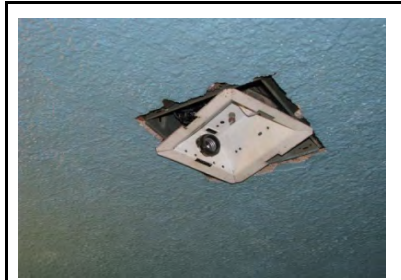
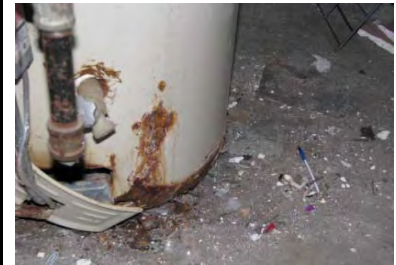
Issue: Exhaust fan/light fixture was loose and missing a cover in the bathroom located on the first floor.

Issue: Corrosion and rust was observed on the base of hot water heater located in the basement of the home.

Issue: No supply or return vents were observed in the bathroom located on the first floor.

Action(s): 1) Re-attach and install a cover on the exhaust fan in the bathroom
2) Operate fan during, and for 15 - 20 minutes after taking shower/bath to help decrease the humidity level during and to prevent mold and bacteria growth.

Action(s): A licensed Heating, Ventilation, and Air Conditioning (HVAC) professional should assess the hot water heater to replace or make necessary repairs in order to prevent future moisture issues and other safety hazards from occurring.

Action(s): Install ductwork to the bathroom on the floor to ensure that fresh air is introduced and to promote air circulation.

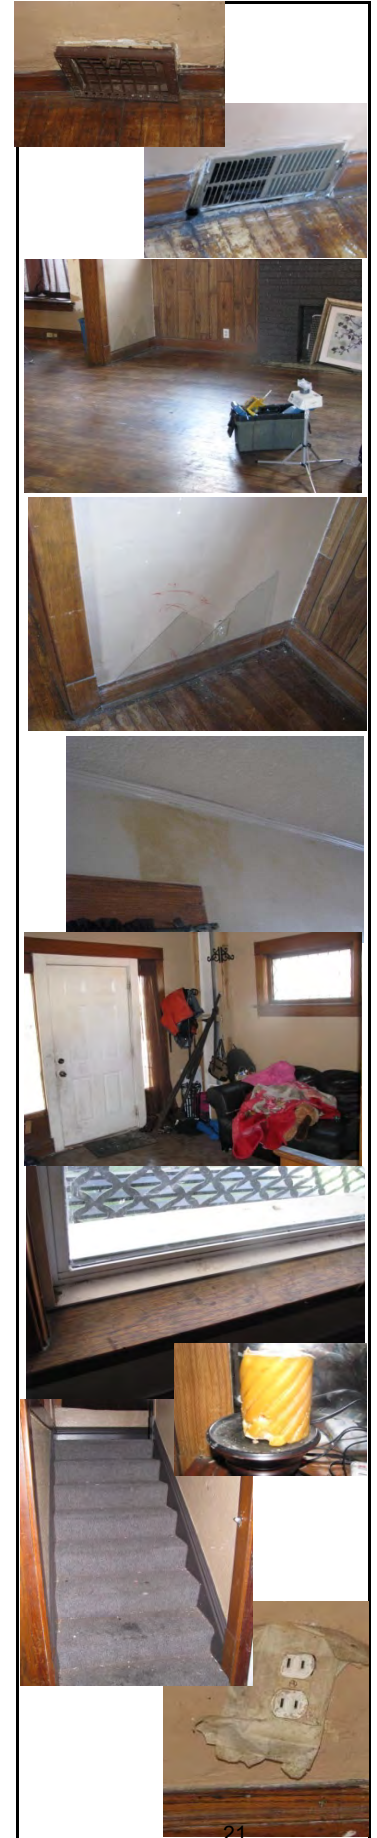
Photos of Issues

OK- Good	Concern	Take Action	Not Applic.	Description	Score
Working supply vent	3					100
Supply vent open	3					100
Supply vent unobstructed	3					100
If return vent present - working	3					100
Return vent(s) unobstructed		2			Slightly by couch	50
If windows present-operational				0		
Room under (+) pressure	3					100
Remarks:	3	2	1		AF & C Score:	92

OK	C	TA	NA	Description	Score
No visible dust		2			On floor & window sill	50
No carpeting present	3					100
Carpet condition				0		
No upholstered furniture	3					100
Upholstered furniture condition				0		
Mattress condition				0		
Bedding condition				0		
No cloth window coverings		2			Curtains present	50
No furry/feathered pets in room		2			One dog	50
No clutter	3					100
No reported/visible evid. of rodents			1		Cochroach issue	0
No reported/visible evid. of insects			1		Mice issue	0
No trash/debris on surfaces	3					100
Remarks:	3	2	1		A & D Score:	61

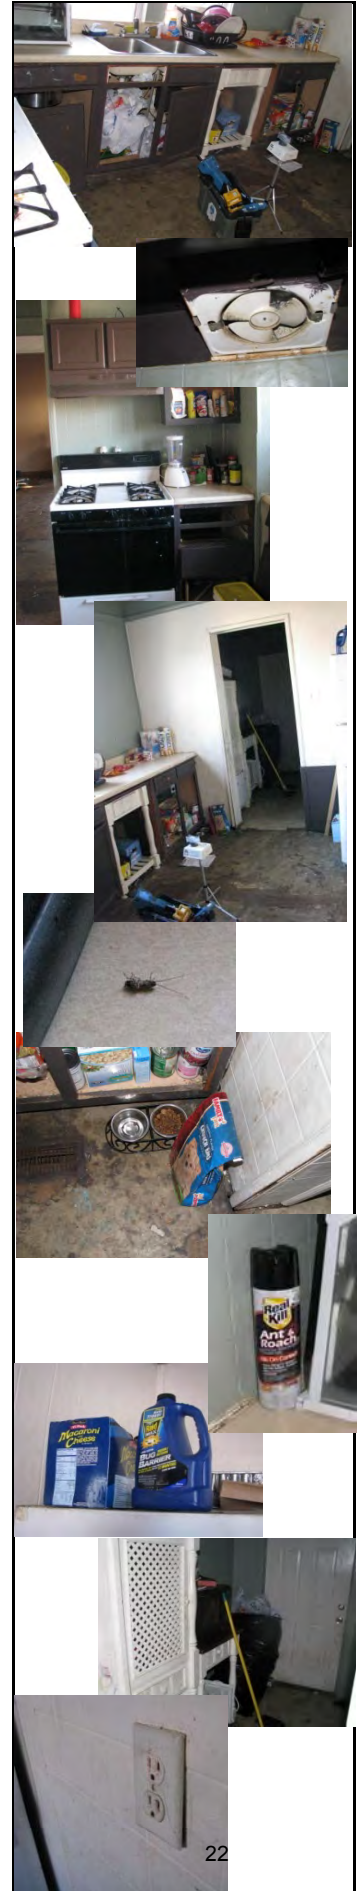
Photos of Issues

OK	C	TA	NA
No visible dust		2		
No carpeting/upholstery present	3			
No cloth window coverings	3			
No furry/feathered pets in room		2		
No clutter	3			
Bulk food in containers	3			
Trash stored in container w/ lid			1	
No cracks/gaps around cabinets		2		
No reported/visible evid. of rodents			1	
No reported/visible evid. of insects			1	
No trash/debris on surfaces	3			
Remarks:	3	2	1
