# EXAMPLES AND PRACTICE

## WORKED EXAMPLES

# TERMS – ENGLISH TO AMERICAN

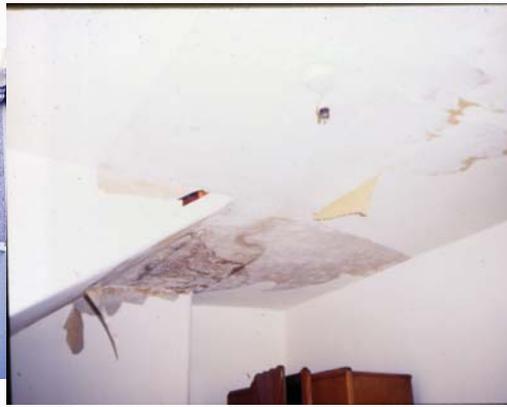
Rear bedroom ceiling

There is damp, water stained ceiling plaster in the rear bedroom caused by a leaking roof around the chimney stack. There is damp, water-stained wall plaster in the half bathroom and also some mold growth.
